# TEST REPORT

Report No : DRCREL1605-0206  
Pages : ( 1 ) / ( 23 ) page

3. Product Name (Model / Serial No.) : Emergency Stop Switch (KSEB-30 Series / - )

# TEST RESULT

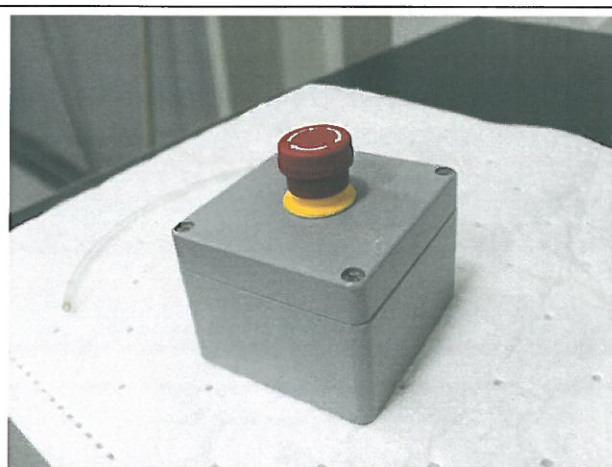
[Photo 1. Emergency Stop Switch]

a. IP66 Product

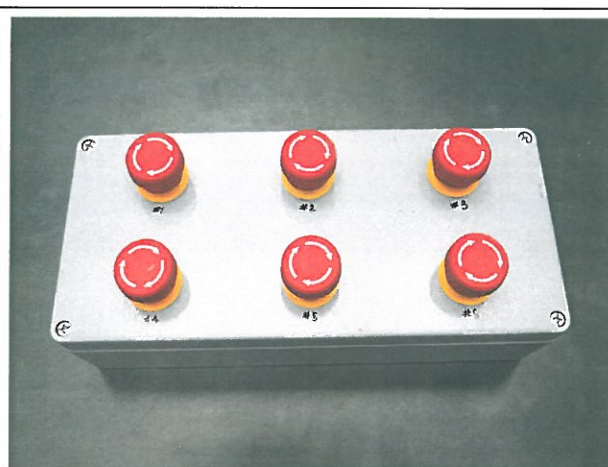
b. Vibration Product

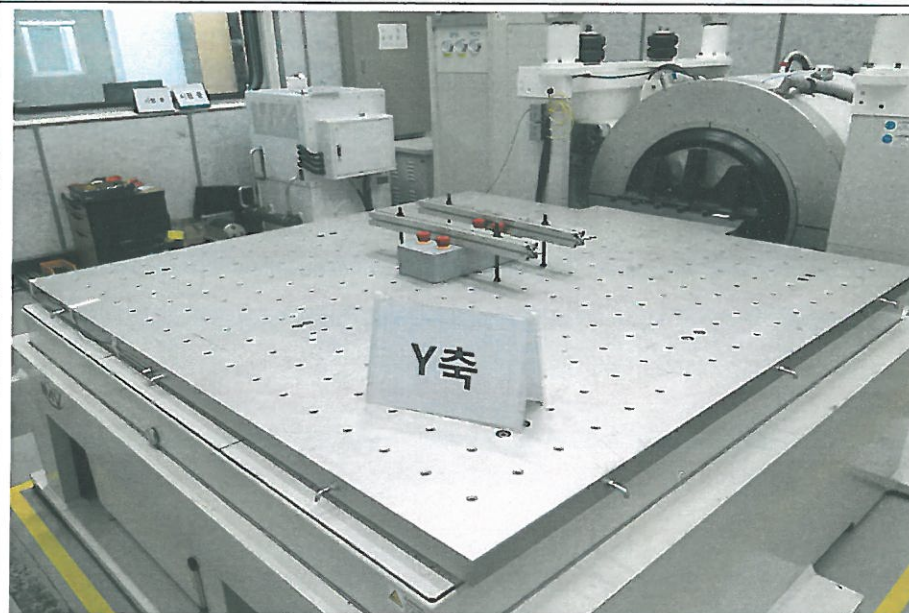
[Photo 2. Test photograph]

b. Y-axis

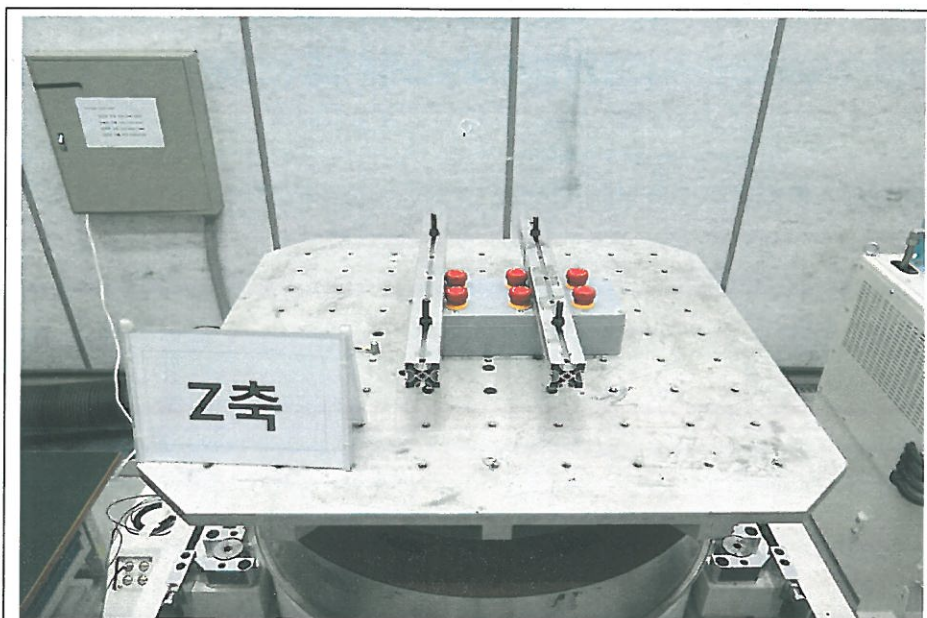
c. Z-axis

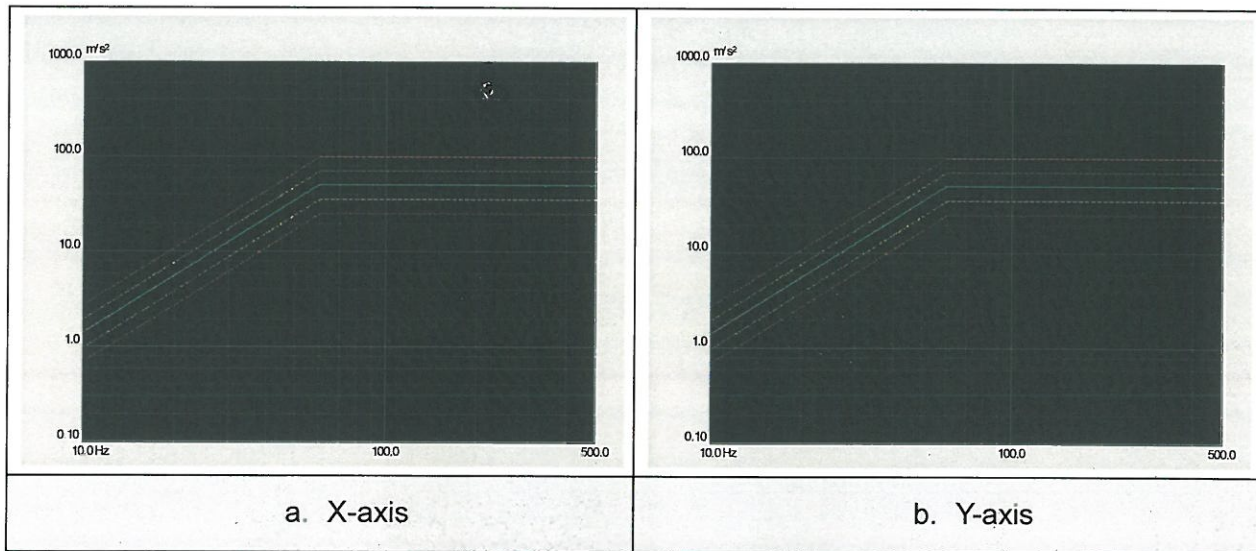
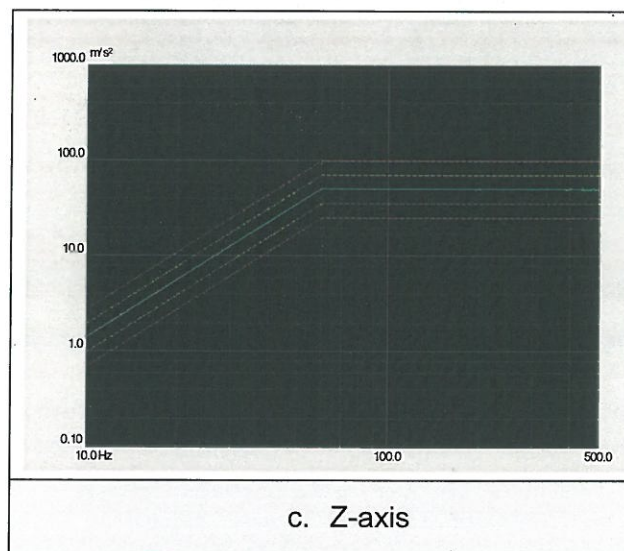
[Photo 3. Test profile]

Frequency (Hz)	Acceleration ( $\text{m/s}^2$ )	Displacement (mm)
(10 ~ 60.15)	-	0.7 (p-p)
(60.15 ~ 500)	50 (0-p)	-

### 1) Test profile

Division	Check list	Test result
Visual	- Mechanical damage such as deformation, crack, separating, loosening of screw, etc.	No abnormal was found

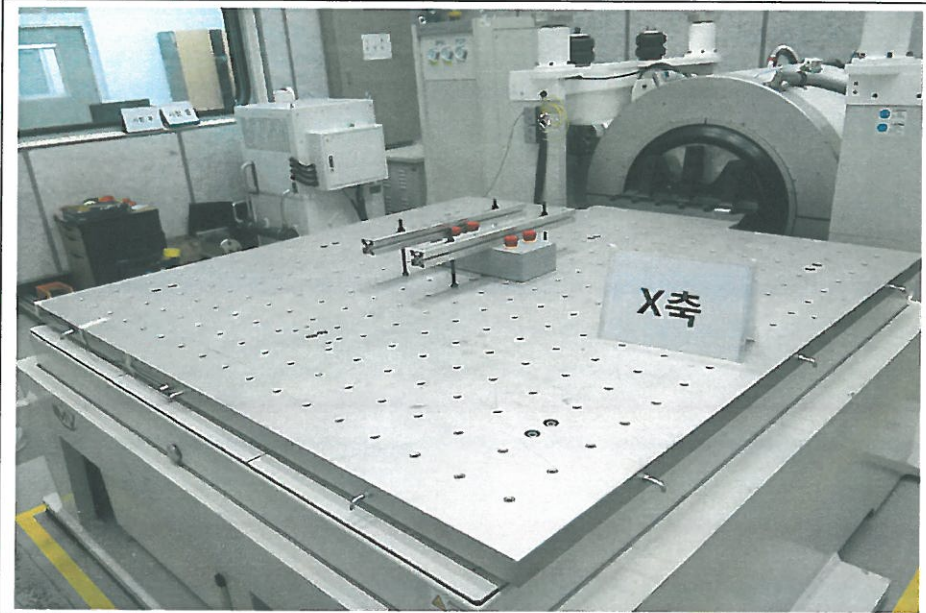
[Photo 4. Test photograph]

- 1) Test type : Half sine
- 2) Acceleration : 15 g
- 3) Duration time : 11 ms
- 4) Test time : 3 times in each axis
- 5) Test axis :  $\pm X$ -axis,  $\pm Y$ -axis,  $\pm Z$ -axis
- 6) Total test time : 18 times
- 7) Sample check : Before the test and after the test visual check
- 8) Sample condition : ① Unpackaged ② Non-Operation
- 9) Sample quantity : 1 Set (6 ea)

- 1) Perform the visual inspection check of the test specimen.
- 2) Fixed the test specimen on the test table.
- 3) Perform the shock test in accordance with test condition.
- 4) Perform the test for the 3-axis. ( $\pm X$ ,  $\pm Y$ ,  $\pm Z$ )
- 5) Perform the visual inspection check of the test specimen.

a.  $\pm X$ -axis

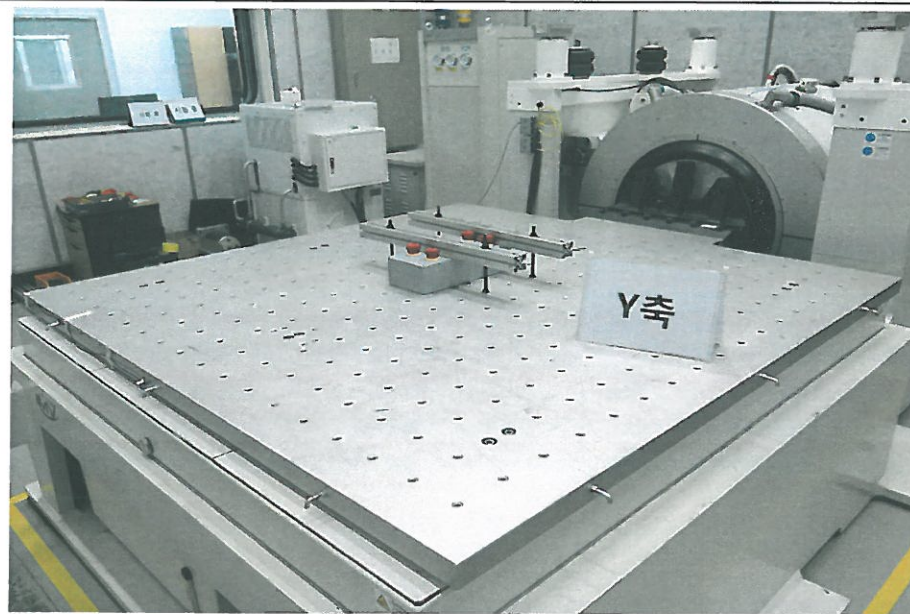
b.  $\pm Y$ -axis

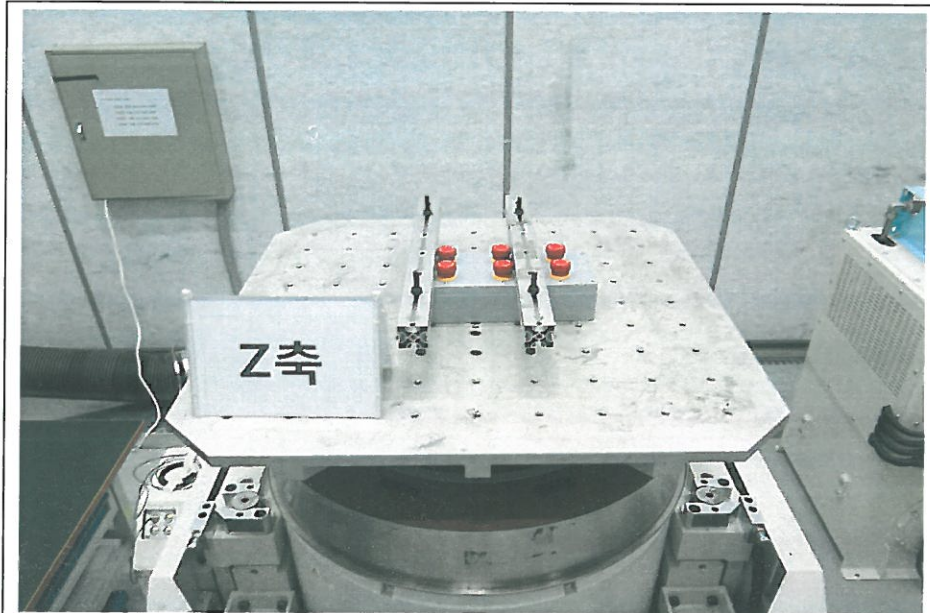
c.  $\pm Z$ -axis

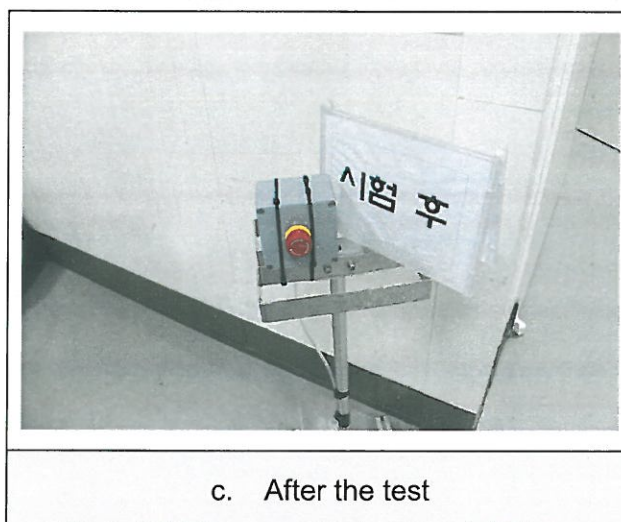
[Photo 6. Test photograph]

- 1) IP Code : IPX6 (Protected against powerful water jets)
- 2) Waterproof rate: 100 x (1 ± 5 %) L/min
- 3) Spray distance : (2.5 ~ 3.0) m
- 4) Test time : 3 min
- 5) Sample condition : ① Unpackaged ② Non-operation
- 6) Sample quantity : 1 ea

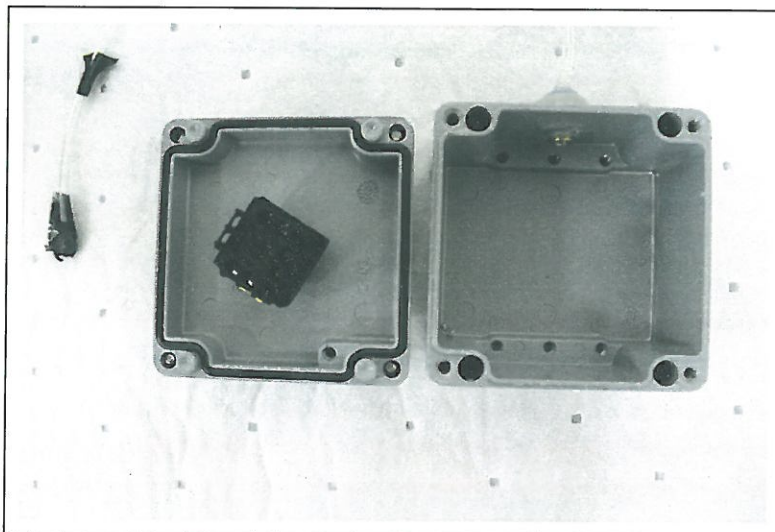
[Photo 8. IPX6 Test result]

(1) IPX6

Check list	Test result
Confirmation of dust penetration	No dust penetration was found (Refer to ※ Appendix 1.)

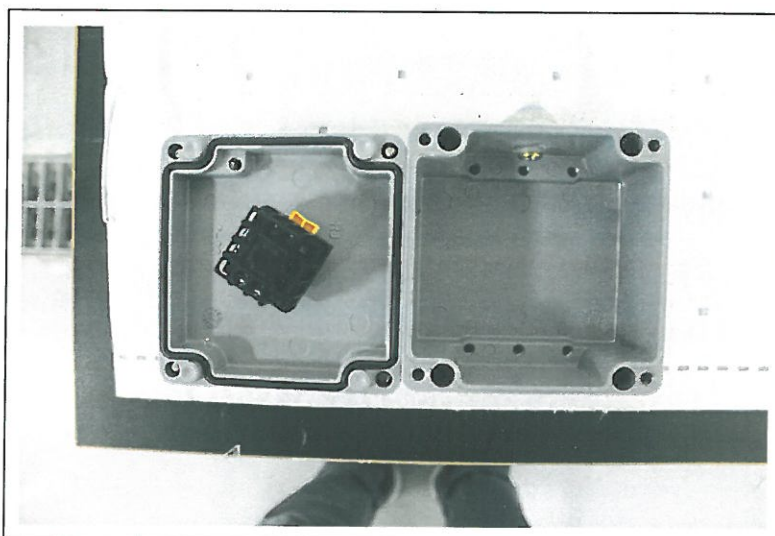
[Photo 9. IP6X Test result]

(2) IP6X

Check list	Test result
Confirmation of dust penetration	No dust penetration was found (Refer to ※ Appendix 1.)
